*Jeroným Mine, old mine workings, stability*

## STABILITY OF OLD MINE WORKINGS OF JERONÝM MINE AT ČISTÁ, SOKOLOV DISTRICT

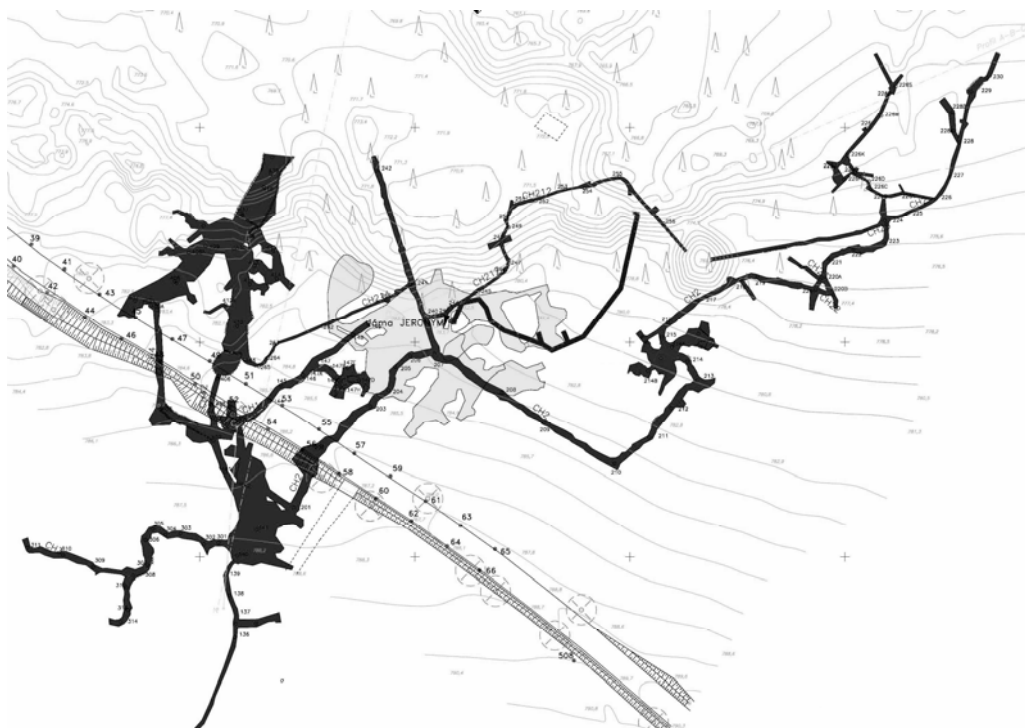
Fig. 1. Jeroným Mine and road No. II/210

In the mine voids of the Jeroným Mine (Fig. 1), rooms after the extracted tin ore with traces of fire setting and passages with characteristic small cross-sections and with traces of work with a hammer and a pick are preserved. In the year 2008, the Ministry of Culture of the Czech Republic established the Jeroným Mine as a national historic landmark. In the future, the opening of this mine working in the form of a historical mining museum to the broad public is expected.

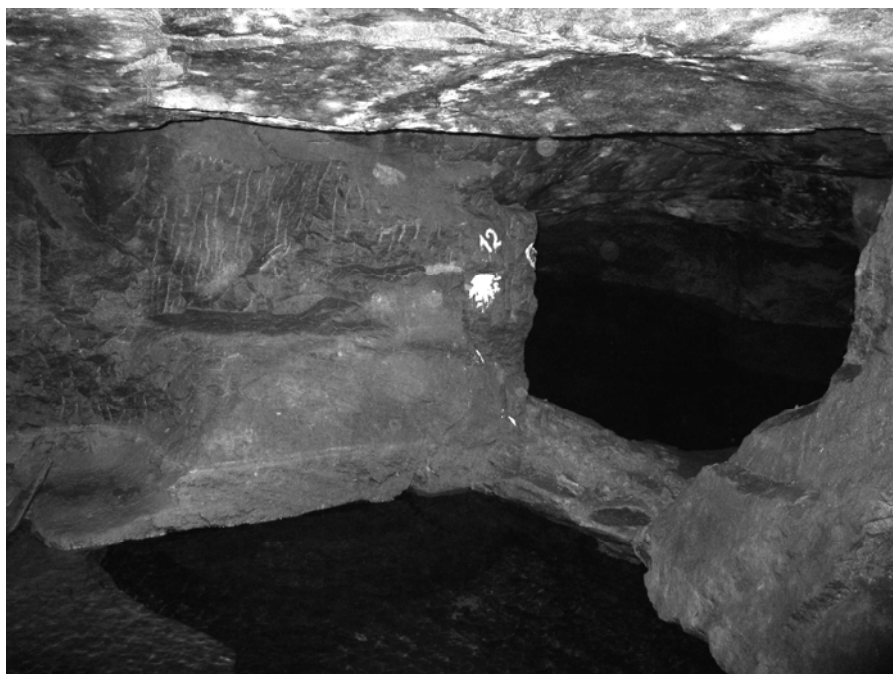
1. The initial state for the observation of geomechanical stability of mine workings in the course of securing works is the current state that is observed by a designed monitoring system [3,6].
2. The same is valid for the assessment of character and geomechanical condition of pillars and pillars between rooms (Fig. 4) and for the evaluation of origin and development of so-called “modern” fissures that have been evaluated so far merely on the basis of visual observation.
3. A strongly unfavourable factor that adversely affects the geomechanical stability of part of the Jeroným Mine is the uncompleted decommissioning of the mine, namely the partial backfilling of the Jeroným shaft. The created cone

Fig. 4. Disturbed arch pillar
