CONTRIBUTION TO THE MAINTENANCE OF T4 BH DRILLING MACHINE (CASE OF THE MINE OF BOUKHADRA, ALGERIA)

Abstract: The current paper presents the study of applying the FEMA method to the drill T4 BH. The research focused on the risk indicators used in the FEMA method. Pareto diagram for the description of the frequency and importance of causes that may cause a problem were applied. With participative method of brainstorming information was gathered concerning the failures that can occur in the drill machine T4BH, their causes and their effects, as well as preventive and error detection methods. The information was then processed by means of different quality instrument (cause-effect diagram) resulting in a ranking of risk coefficient used in the FMEA method.

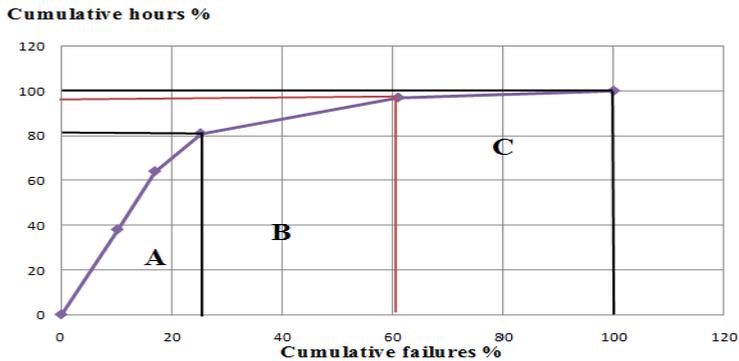
Fig. 4. Pareto diagram

Zone A: we note that 25.42% of subsets cause 81% of downtime. The equipment concerned by this zone are : drilling motor, compressed air circuit and hydraulic circuit so special attention should be given to these parts.

Zone B: This zone indicates that 35.59% of elements are responsible for 16% of downtime. The concerned equipments are the auxiliary circuit.

Zone C: It consists of advancing and drilling circuit. It represents 61% of equipments, but only 3% of the resulting downtime.

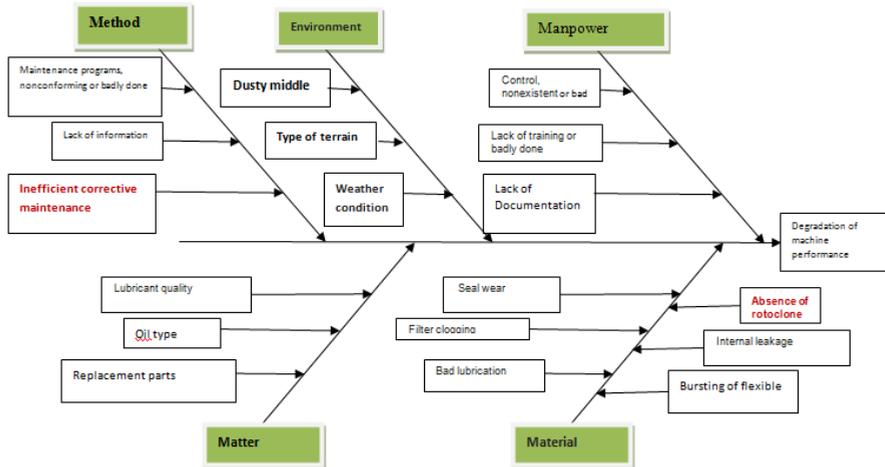
Fig. 5. Ishikawa diagram

Material: the type of oil, lubricant quality and improper replacement parts are the factors affecting the profitability of the machine.

Environment: The dusty environment is the major factor that increases downtime. The huge dust is due to the fact that the machine does not have a protective device against dust: Rotoclone. The Rotoclone is a hydrostatic precipitation with an integral fan. It cleans the air by the combined action of the centrifugal force and violent intermingling of the water and the dust-laden air. Its role is to aspirate the dust generated during the drilling operation.

Manpower: The lack of training and qualification of employees are major problems it is imperative to resolve .It there's also a lack of ongoing training and paucity of intervention procedure makes it more difficult spots.

Machines: The machines are typically used in poor conditions (poor lubrication, improper adjustment) that causes internal leakage and bursting flexible and the wear

of joints. Lack of rotoclone poses the major problem with the machine in the quarry because the dust affects directly the functioning of the filters, motor and compressor.

Method: The lack of information on the state of the machine and the ineffectiveness of the corrective maintenance makes the task of maintenance personnel, difficult. It becomes necessary to position an intervention team, closer to the machine.
