## **LABORATORY TESTING OF CONVEYOR TEXTILE BELT JOINTS USED IN UNDERGROUND MINES**

**Abstract:** In order to achieve the high standards of safety and operational reliability required of belt conveyors, there is a requirement for systematic testing of conveyor belts and their joints. This article describes joint testing methods and presents an analysis of the causes of reduced strength of multi-ply belt joints. Testing was carried out at the Belt Conveying Laboratory (LTT) of Wrocław University of Technology. Presented here is a proprietary method for the measurement of stress distribution in conveyor belt adhesive joints.

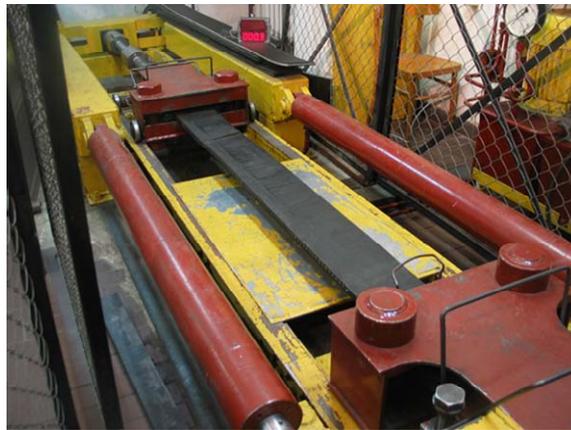
The tensile strength of fabric belt joints is determined with samples 200 mm wide and stretched lengthwise as per the requirements of PN-C-94147:1997. Such tests are performed on a purpose-built tensile strength testing machine as shown in Figure 2. Tested joints can have different structures, which is shown schematically in Figure 1.

Fig. 2. Tensile testing machine ZP-40 for belt joints
